# Better Assessment of Operational Suitability

Volume II: Case Studies

TE101R1

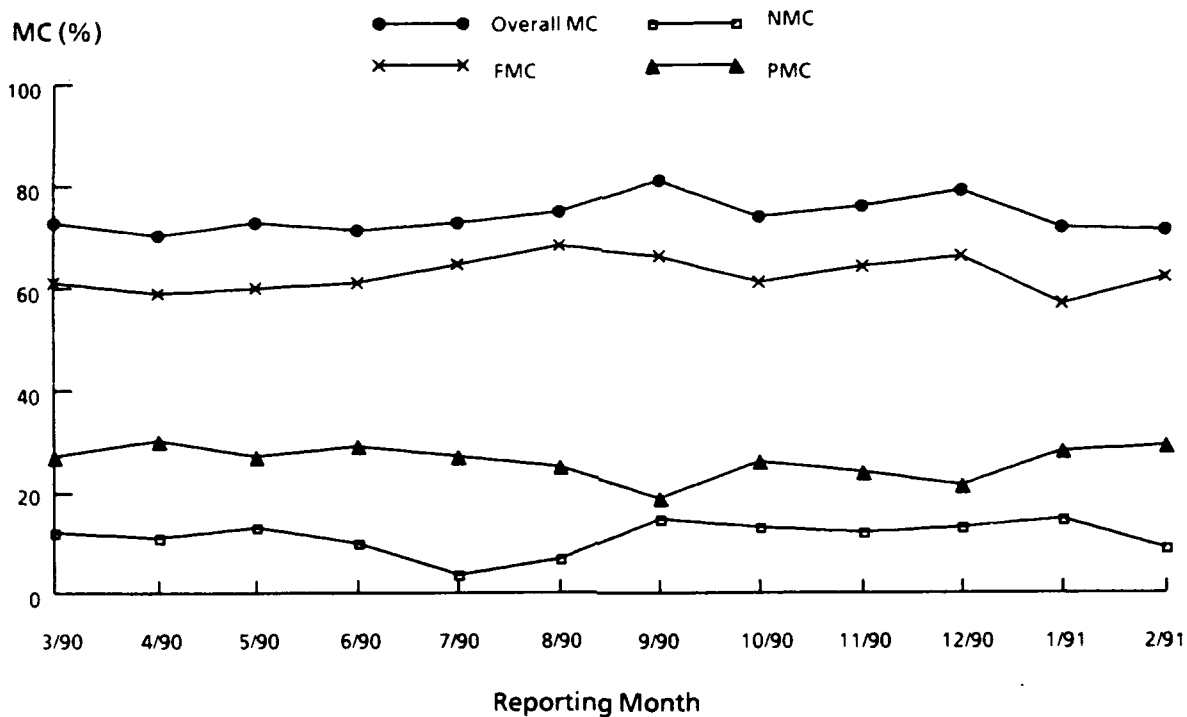
FIG. 3-1. AH-64 WORLDWIDE READINESS - MARCH 1990 THROUGH FEBRUARY 1991

We obtained worldwide mission capability rates for the AH-64 for the period March 1990 through February 1991. The rates are based on 605 aircraft, of which 532 are assigned to units. FMC, PMC, and NMC rates are shown in Figure 3-1. We also include the sum of FMC and PMC rates as the overall MC rate.

The Army has established a FMC goal of 70 percent and a PMC goal of no more than 5 percent. These goals were not achieved during the period covered by our review.

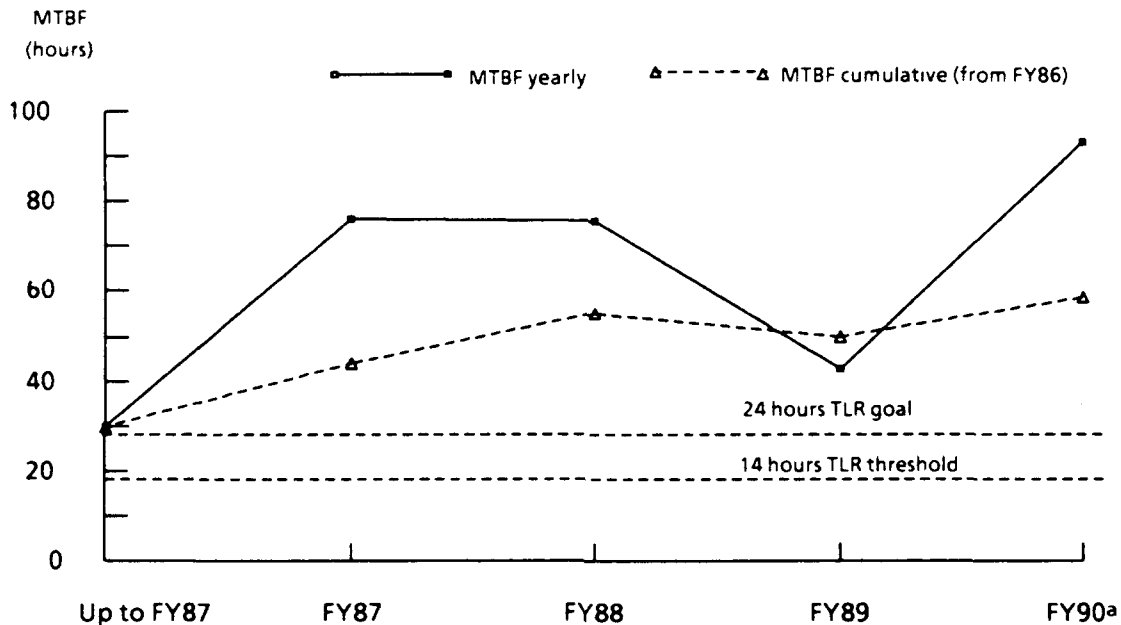
Source: LCAC reliability and maintainability summaries produced by NCSC [13].

Note: Rates reflect all critical failures, including those caused by operator error and by failures of other components.

FIG. 5-1. LCAC MEAN TIME BETWEEN CRITICAL FAILURES

The results are impressive. FY90 mean time between critical failures (all causes) was over 90 hours, more than 3 1/2 times the system goals established in the TLR (see Figure 5-1) [13].

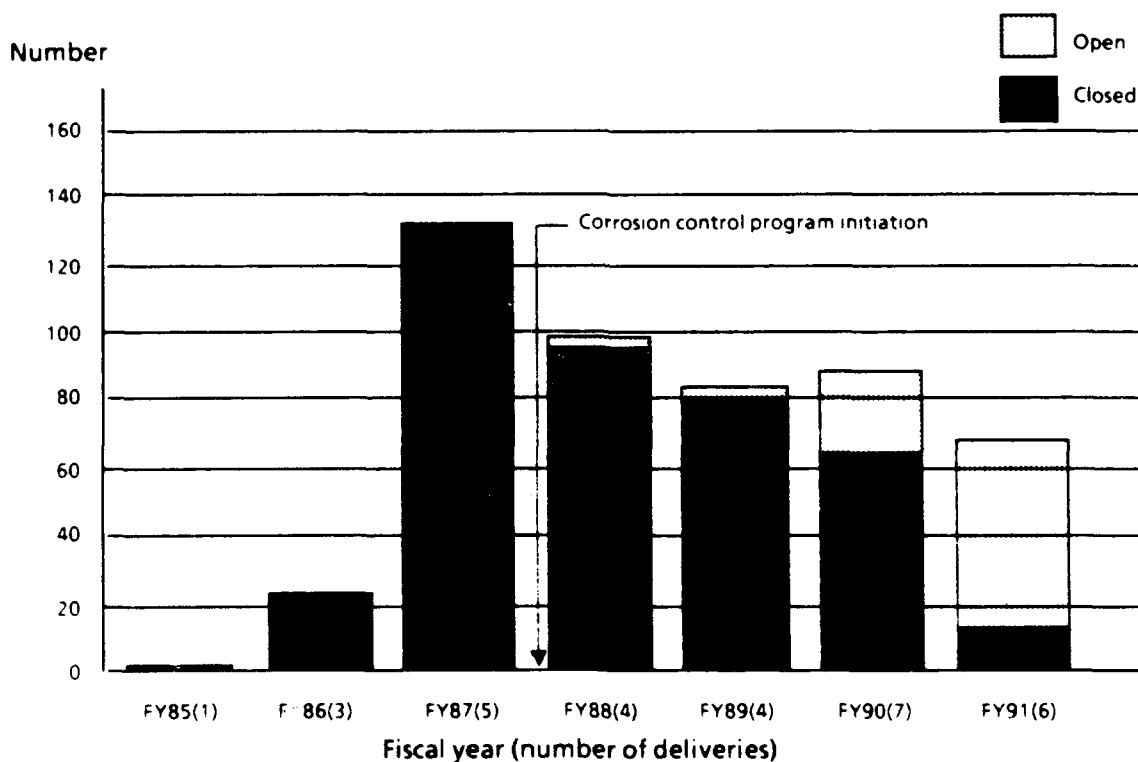
FIG. 5-2. NUMBERS OF CORROSION REPAIR SITES, BY FISCAL YEAR

The program's effectiveness in closing out (by means of repairs or vehicle modifications) sources of corrosion is shown in Figure 5-2. The beginning of the corrosion control program is identified at the start of FY88. Few corrosion repair sites are indicated for the first four LCACs (FY85 and FY86), because the contractor, under the terms of the original contract, corrected deficiencies as they were found, and the extent of the corrosion problem was not known until sufficient operational hours had been accumulated.

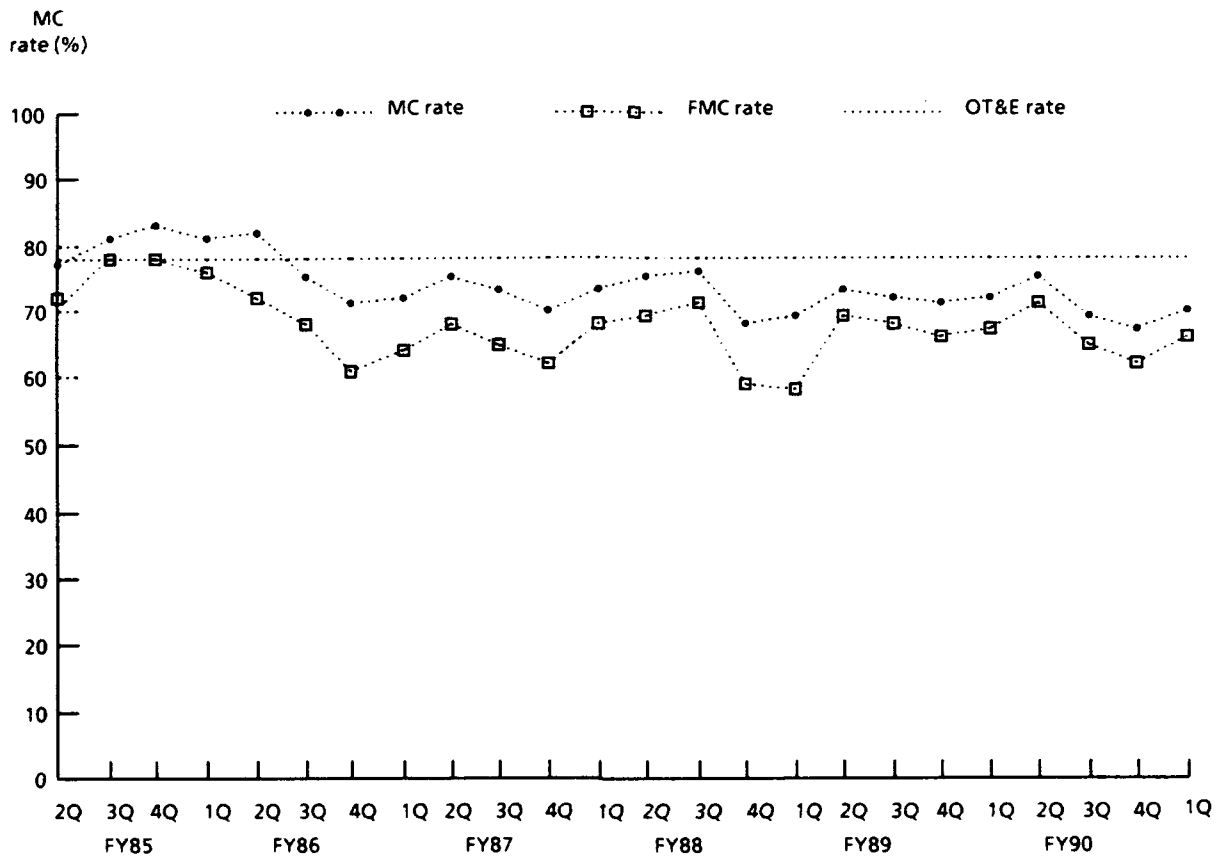
FIG. 6-1. AV-8B MISSION CAPABLE RATES

Figure 6-1 shows the MC rate observed in OT&E (78 percent, which exceeded the criterion of 70 percent) and the MC rates achieved over the last 5 years for the AV-8B. Field experience for fully mission capable (FMC) rates achieved met the rate observed in OT&E only in two quarters in early operations. Since that time, FMC rates have failed to achieve that experienced in OPEVAL. MC rates have also declined from early experience and have fallen short of the goal of 80 percent set for the AV-8B (the goal was recently changed to 76 percent).

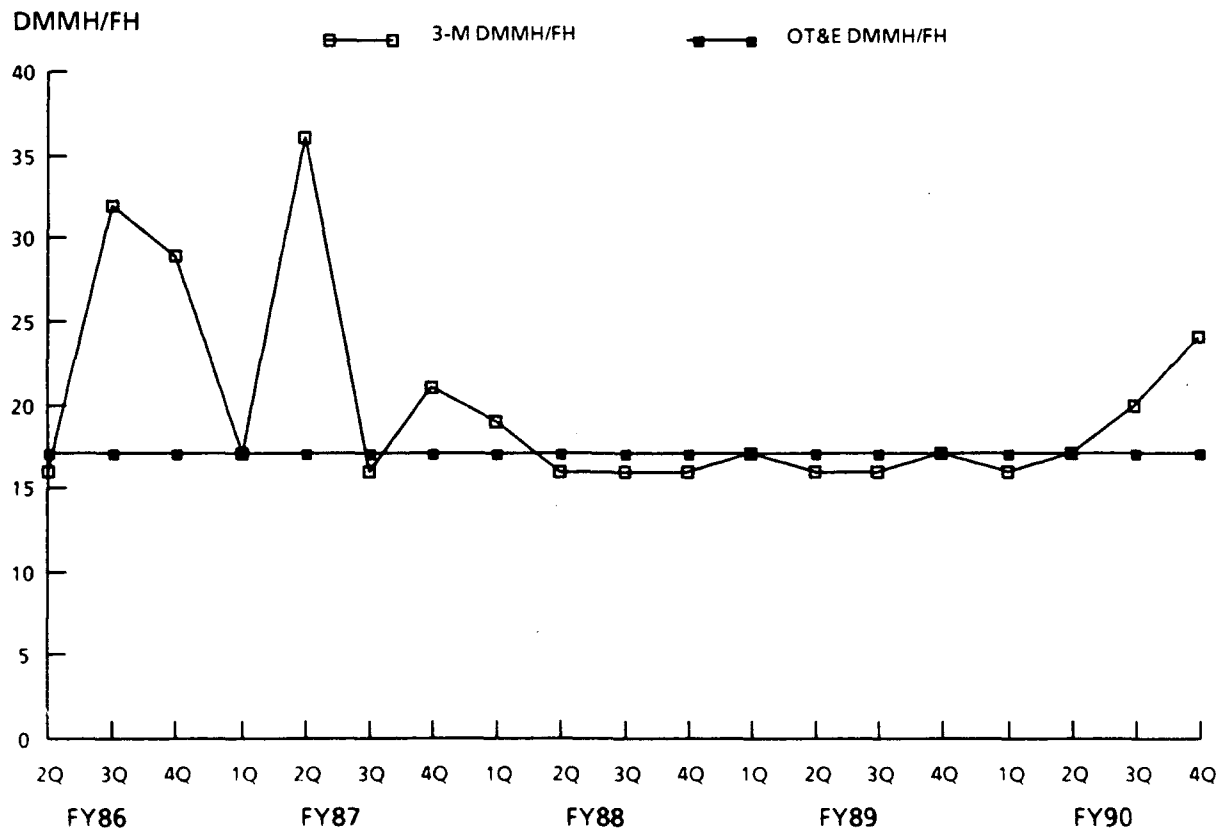
FIG. 6-2. AV-8B DIRECT MAINTENANCE MAN-HOURS PER FLIGHT HOUR

Figure 6-2 shows the DMMH/FH observed in OT&E, and the most comparable field experience numbers available (O-level DMMH, including scheduled and unscheduled Maintenance Actions and Support Actions). Many factors can influence the behavior of DMMH/FH. For example, if flight hours go down in a month and maintenance hours remain constant, then DMMH/FH goes up. If maintenance hours go up in response to a supply problem, then DMMH/FH will go up, particularly if the supply problem results in grounded aircraft (which reduces flight hours). Suffice it to say that there was a great deal of volatility in the experienced DMMH/FH in the early years (FY86 and FY87). In the later years (FY88 through FY90), the value of 17.1 DMMH/FH observed in OPEVAL was a remarkably good indicator of actual field experience, as Figure 6-2 shows. The last quarter of FY90 includes August, which may show some effects of preparing for deployment to SWA.

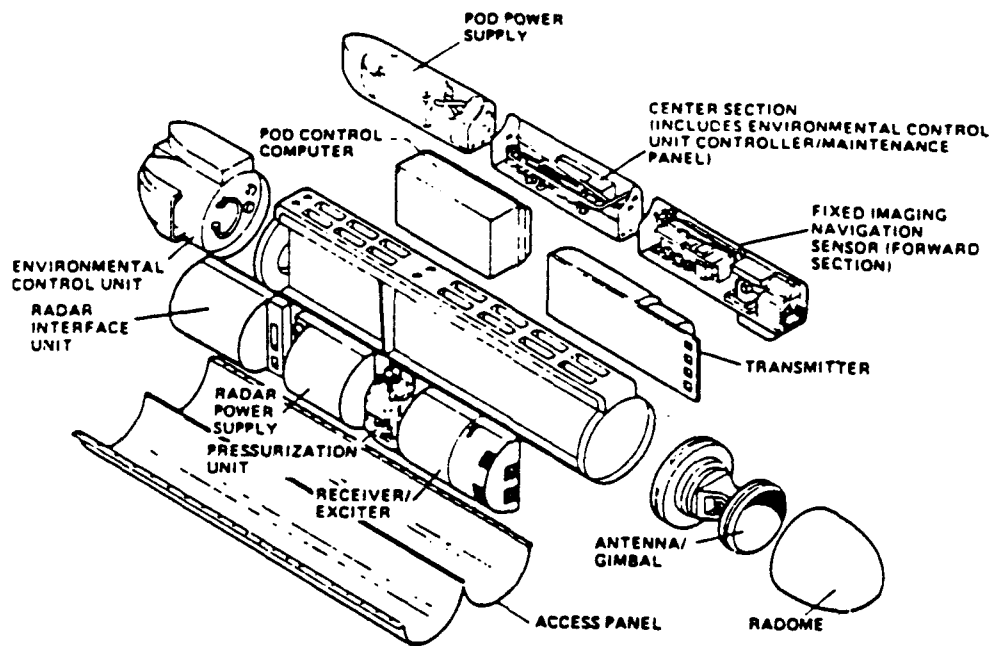
FIG. 7-1. MAJOR SUBSYSTEMS OF THE NAV POD

The NAV pod contains a forward-looking infrared receiver (FLIR), a terrain-following radar (TFR), a pod control computer, a power supply, a servo-control, and environmental control subsystems. Figure 7-1 shows the major subsystems of the NAV pod. The pod is approximately 78 inches long, 12 inches in diameter, and weighs 430 pounds. The FLIR provides an unmagnified (one-to-one) thermal image of the external scene for display on the WFOV HUD. The TFR provides a signal to position a HUD terrain-following cue that the pilot uses for manual terrain following. In addition, an automatic terrain-following capability is included.

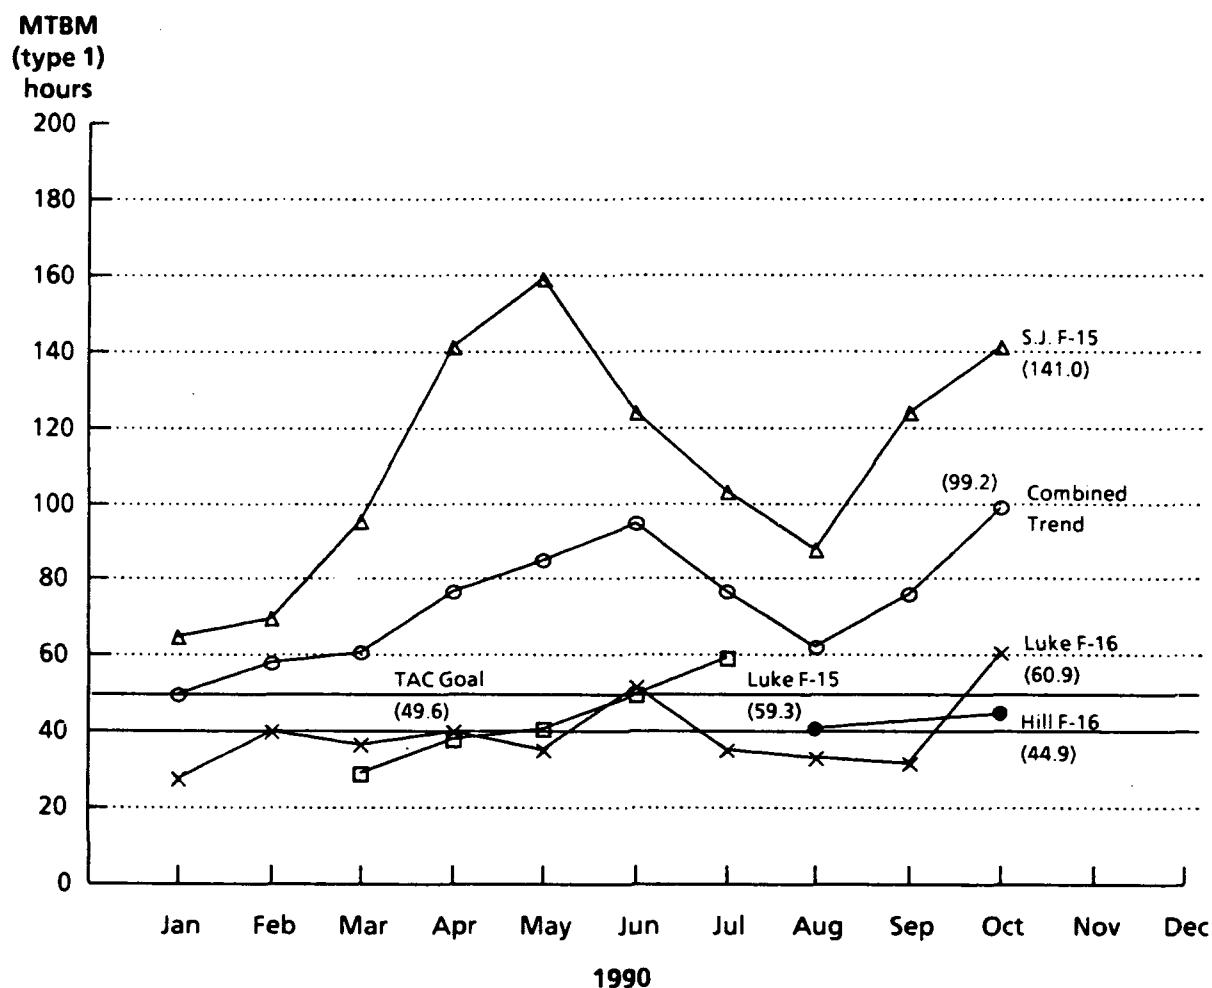
FIG. 7-3. THREE-MONTH MOVING AVERAGE OF MTBM-I FOR THE LANTIRN NAV POD (BASED ON TAC DATA SCORED BY THE SPO AND THE PRIME CONTRACTOR [12])

Reliability and maintainability data for LANTIRN are collected by TAC. The SPO and the contractor classify the failures as inherent, induced, or CND/RTOK. Figure 7-3 shows the MTBM-I results for the first 10 months of 1990 [12]. Those data represent over 12,000 flight hours of Lot 3 pods. The figure shows that MTBM-I of the total population exceeds the required value of 49.6 hours. Most of the data points below the requirements are from Luke AFB, which is a training base.

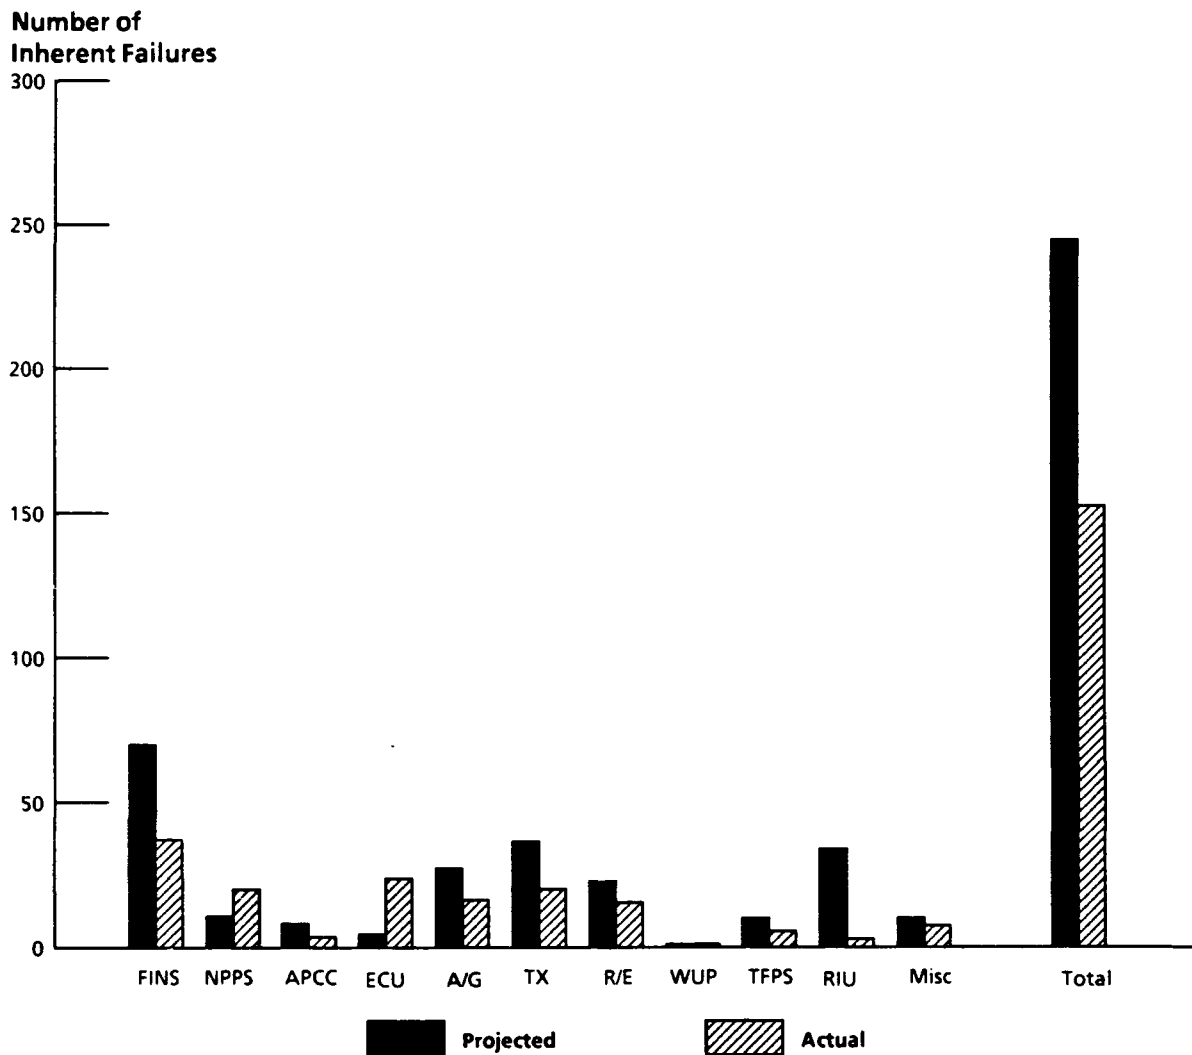
**FIG. 7-4. COMPARISON OF PROJECTED AND ACTUAL FAILURES FOR NAV POD LRUs (LOT 3; 1 JAN – 30 OCT, 1990; 12,127 HOURS; TAC DATA SCORED BY THE SPO AND THE PRIME CONTRACTOR [12])**

Figure 7-4 shows the inherent (Type 1) failures of Lot 3 NAV pods for the first 10 months of 1990. The number of observed failures is less than two-thirds of the number predicted by the contractor. Furthermore, the figure for mean flight hours between inherent failure is 79.8, which exceeds the MTBM-I requirement of 49.6 operating hours.

The major reliability problems today are the FINS, the environmental control unit (ECU), the power supplies, the TFR XMTR, the receiver/exciter (R/E), and the antenna/gimbal (A/G) assembly. These components account for about 90 percent of the pod failures shown in Figure 7-4. Most of these components now fail less

frequently than predicted. The major exception is the ECU, which has failed about four to five times more frequently than predicted.

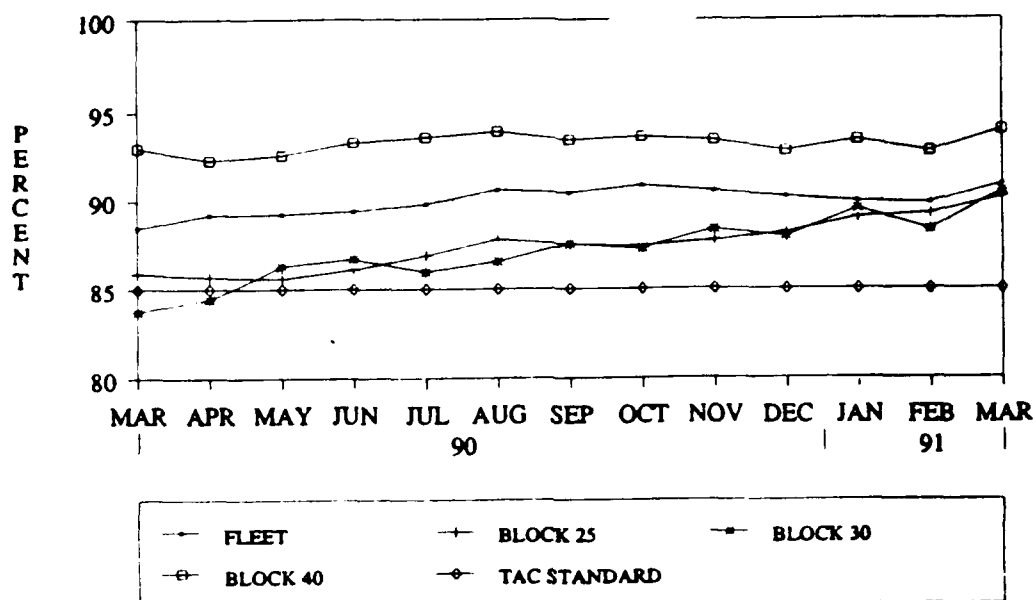
FIG. 8-2. MISSION CAPABILITY RATES - USAF F-16 C/Ds

Block 40 IOT&E (combined with experience from preceding blocks) indicated that the aircraft's availability would exceed minimum TAF thresholds (85 percent MC rate). That expectation has been borne out in field experience; as indicated in Figure 8-2 [2], MC rates for Block 40 F-16s have consistently exceeded those for earlier F-16s and, currently, are among the highest ever experienced for tactical aircraft.

The field experience recorded in Figure 8-2 includes the wartime experience during the SWA campaign. Block 40 F-16s had very high MC rates during Operation Desert Shield/Desert Storm (for example, the 388 Tactical Fighter Wing (TFW) had FMC values of 94 percent [8]). These high rates, coupled with the fact that CONUS-based units were not "robbed" to support the deployment, allowed the overall MC rates shown in Figure 8-2 to remain steady throughout the deployment period.
